# Quality Resource Guide

## Diagnosing & Managing the Cracked Tooth Part 2: Vertical Root Fractures

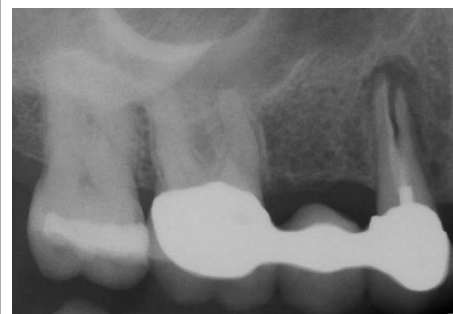
Figure 1

A vertical root fracture (VRF) in the mesial abutment tooth of a 3-unit fixed bridge - apical origin of the fracture is evident.

Vertical root fractures (VRF) occur most commonly in restored endodontically treated teeth (**Figure 1**)<sup>2</sup> They typically originate at the root apex and progress toward the crown. But the fractures can also originate in the mid-root region at the terminus of posts and in the cervical part of the root.<sup>3</sup> Although these fractures often are asymptomatic initially, they allow ingress of bacteria into the fracture lines leading to bone resorption and periodontal pocket developments.

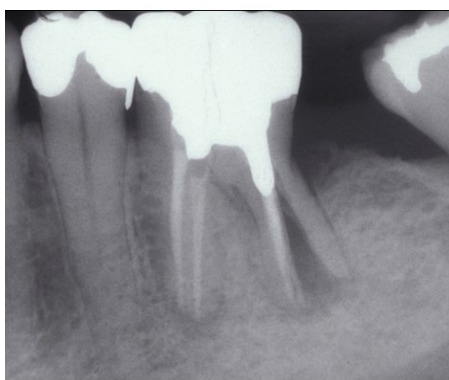
Figure 4

Vertical root fractures typically originate in the apical area and progress toward the crown.

Vertical root fractures usually start in the apical region of a root, where endodontic files may have created micro fractures during canal preparation (**Figure 4**);<sup>13,14</sup> however, recent evidence questions the role of canal preparation.<sup>7</sup> It is not known how extensive a fracture needs to be to create symptoms. Teeth most susceptible to VRF are those with

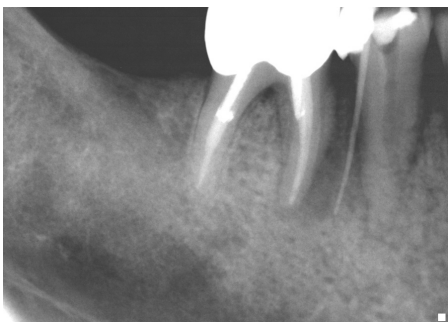
Figure 7

Tooth #30 has a VRF in the mesial root that has resulted in a periodontal pocket that can easily be probed to the apical area without discomfort to the patient (a gutta-percha point is used for radiographic purposes).

periodontal pockets), no one finding is singularly definitive of VRF. The periodontal pockets that form are not as narrow as those associated with a COF and can usually be probed without using an anesthetic (Figure 7).<sup>17</sup>
